Manhole Inspection Summary

Manhole # S19WW_F01MH

Location Address: **1876 MANSION HOUSE DR** Cross Street: **GOLF COURSE**

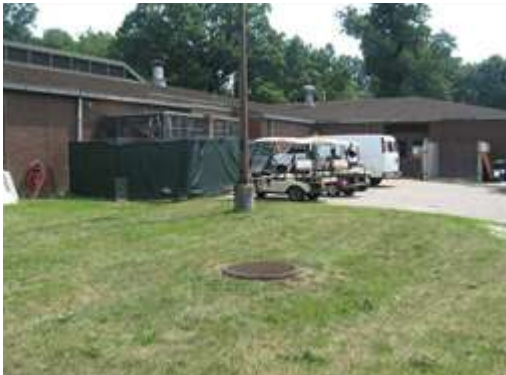
Location View

1876 Mansion Dr (Baltimore zoo)

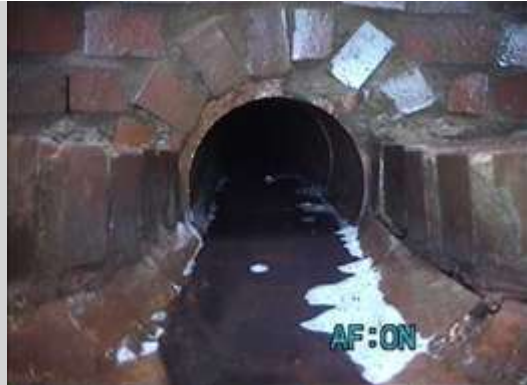
8 in. Circular Gravity Sewer Pipe Out @ 12 O'Clock

Pipe Material: **Clay** ☐ Pipe Lined

Invert Depth: **14.65** (ft.) Flow Characteristics: **Slow**

Infiltration: **None**

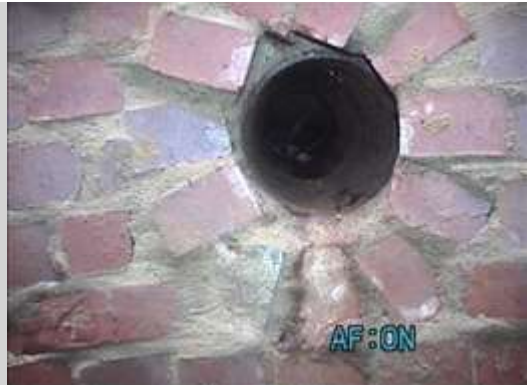
8 in. Circular Gravity Sewer

Pipe Material: **Clay** ☐ Pipe Lined

Invert Depth: **7.54** (ft.) Flow Characteristics: **Slow**

Infiltration: **None**

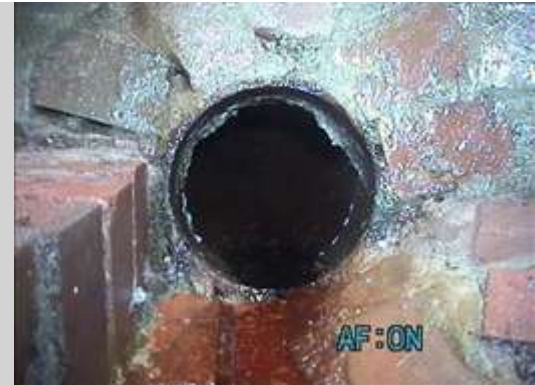
Drop In @ 5 O'Clock

Drop: Inside	Rod and Bar
Angled: Yes	Reading: 13.05 (ft.)
	Inv Depth: 14.05 (ft.)
Drop Condition: Open

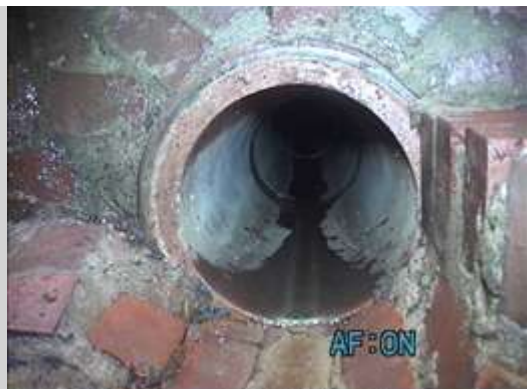
8 in. Circular Gravity Sewer

Pipe Material: **Clay** ☐ Pipe Lined

Invert Depth: **14.12** (ft.) Flow Characteristics: **Slow**

Infiltration: **None**

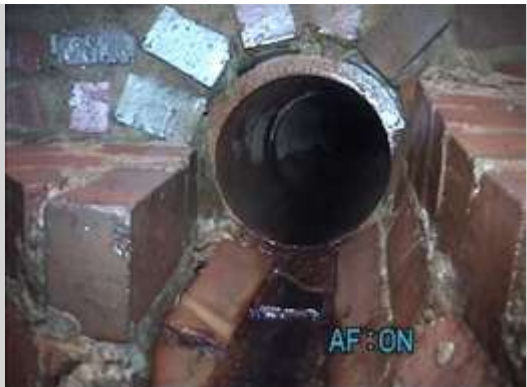
8 in. Circular Gravity Sewer
Pipe In @ 9 O'Clock

Pipe Material: **Clay** ☐ Pipe Lined

Infiltration: **None** Pipe Seal Cond: **Unknown**
